ORIGINAL PAPER

Assessing sustainability and management challenges in small-scale irrigation: Insights from the Amiba Garno scheme in Upper Blue Nile Basin

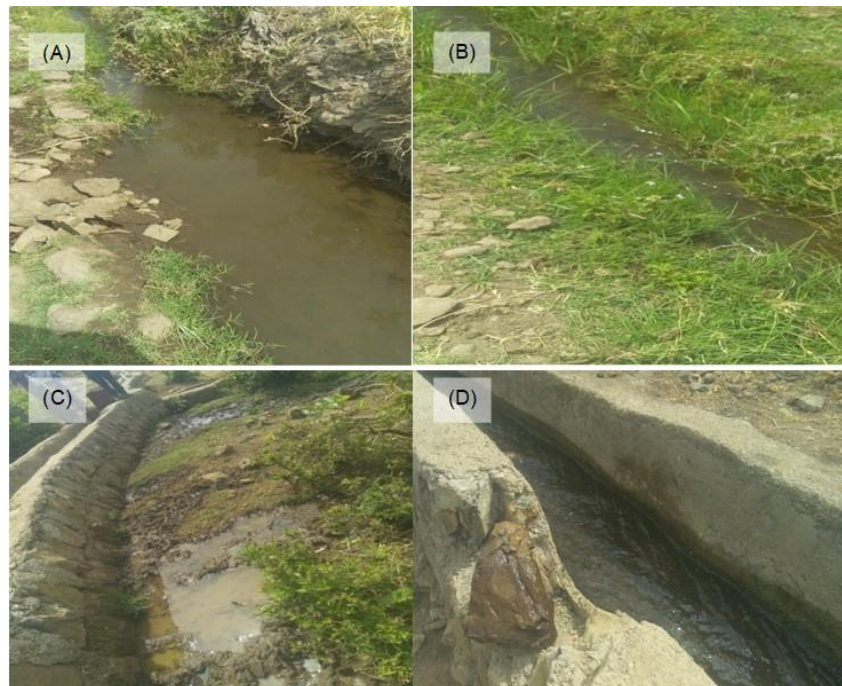
The conveyance efficiency (EC) of the scheme was found to be 88% in the lined main canal and 63 in unlined main canals, indicating water loss of 12 and 37%, respectively. These losses are higher than those reported by Abera et al. (2019) for the Bebeks and Shina irrigation schemes, both found in the Lake Tana sub basin. Factors contributing to the low efficiency may be related to sedimentation, seepage, weed growth, and unauthorized water withdrawals (Figure 2). During a field campaign, illegal water abstraction on the main canal was observed, with local residents for domestic purposes such as drinking water, washing clothes, and bathing. Addressing these issues is essential

Figure 2. Consequences of water loss in the main canal (A), growth of grasses and weeds (B), seepage loss (C), and unauthorized water turnout by farmers (D), during the field campaign in December 2023.

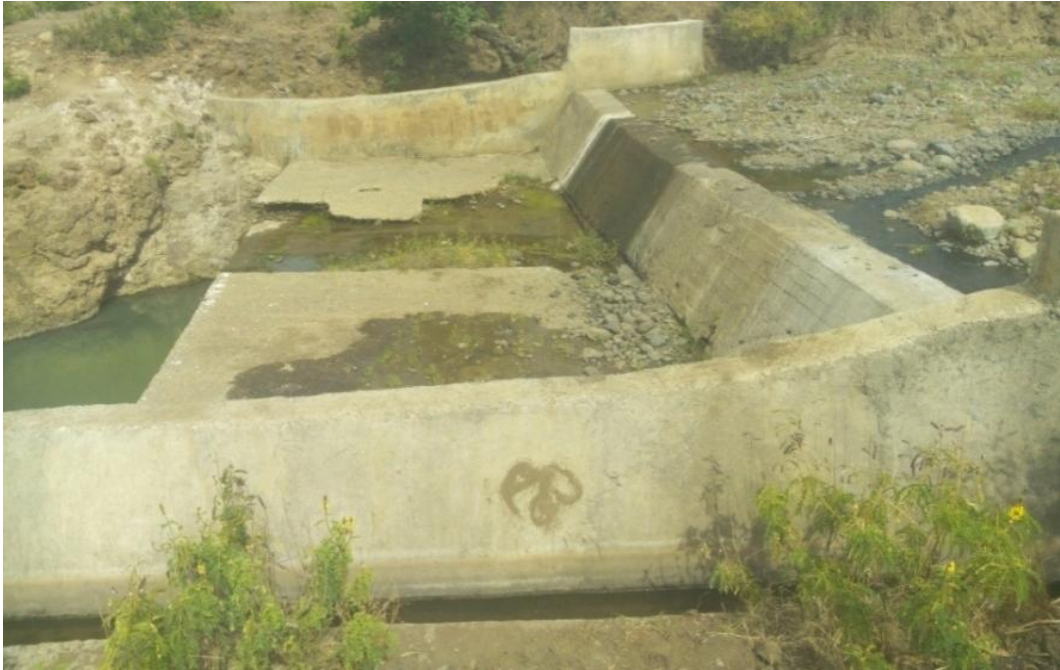
Figure 3. Scour at the downstream of the weir and abrasion of launching apron.

The infrastructure effectiveness (EI), reflecting the need of maintenance, is found to be 59.38%, with only 38 out of the 64 constructed structures are functional (Table 6). As suggested by Mekonnen et al. (2022), the analysis indicates that repair or rehabilitation of the physical structures is necessary as the EI value exceeds the 5% threshold.
